**PHASE I ENVIRONMENTAL SITE ASSESSMENT  
GEORGETOWN STEAM PLANT PERMANENT ACCESS EASEMENT  
KING COUNTY INTERNATIONAL AIRPORT  
SEATTLE, WASHINGTON**

**September 15, 2004**

**815.010.01**

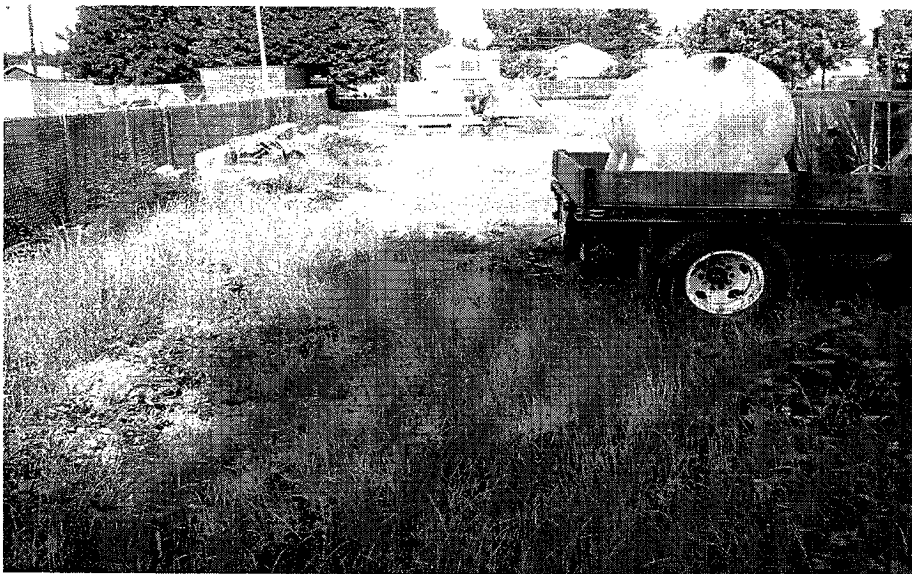
**Comments:**  
Former WSDOT  
Motor Pool site.  
Former building was  
located in gravelly  
area in background.  
Vehicle is from a  
company using the  
site for parking  
vehicles.

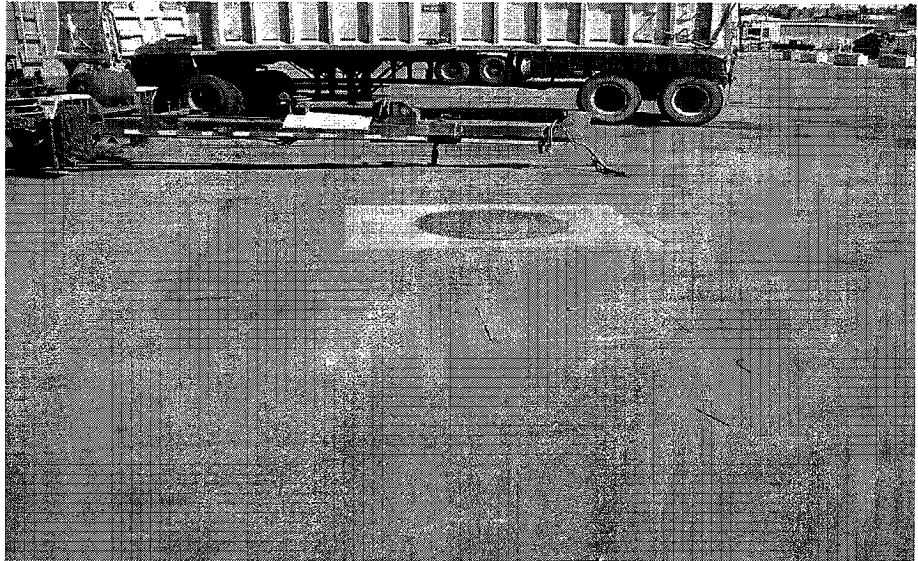
**Comments:**  
Oil/water separator  
at Great NW Soil  
Conditioning truck  
maintenance facility.

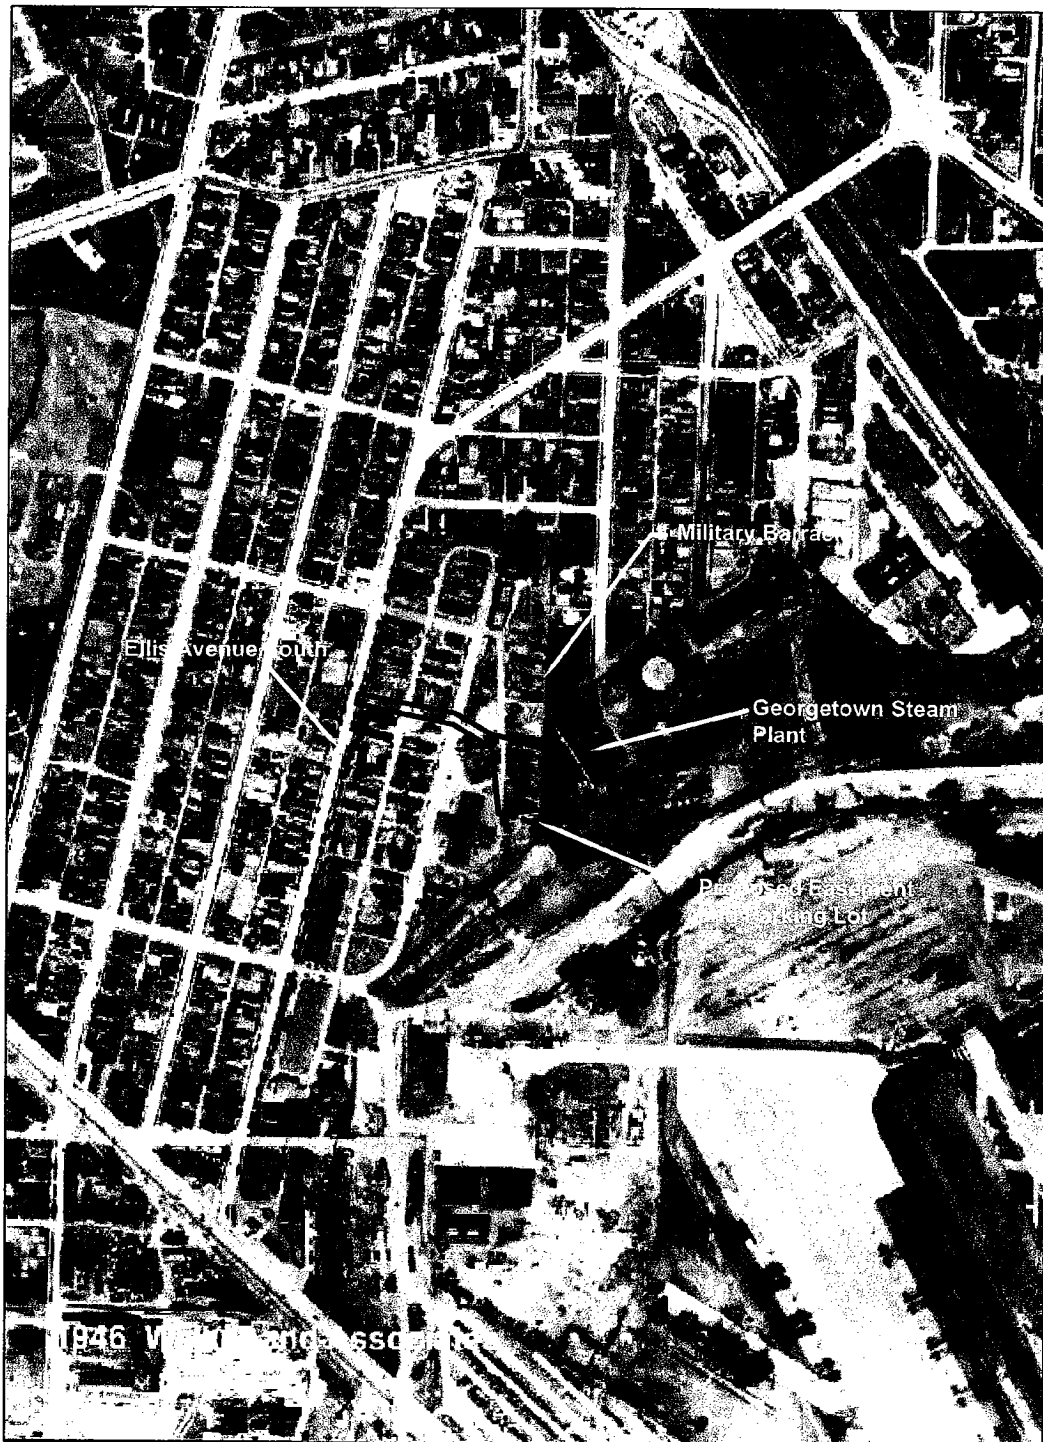
Georgetown Steam Plant Permanent  
Access Easement  
Aerial Photograph - 1946

**1946:** The proposed easement area and vicinity to the north and west was heavily developed. A building was observed on the northeast corner of the ANGS property in the
